# Innovations and Collaboration:

Acquiring and Delivering Waterfront Restoration and  
Modernization Projects

# **Innovation and Collaboration in Acquiring and Delivering Waterfront Restoration and Modernization Projects**

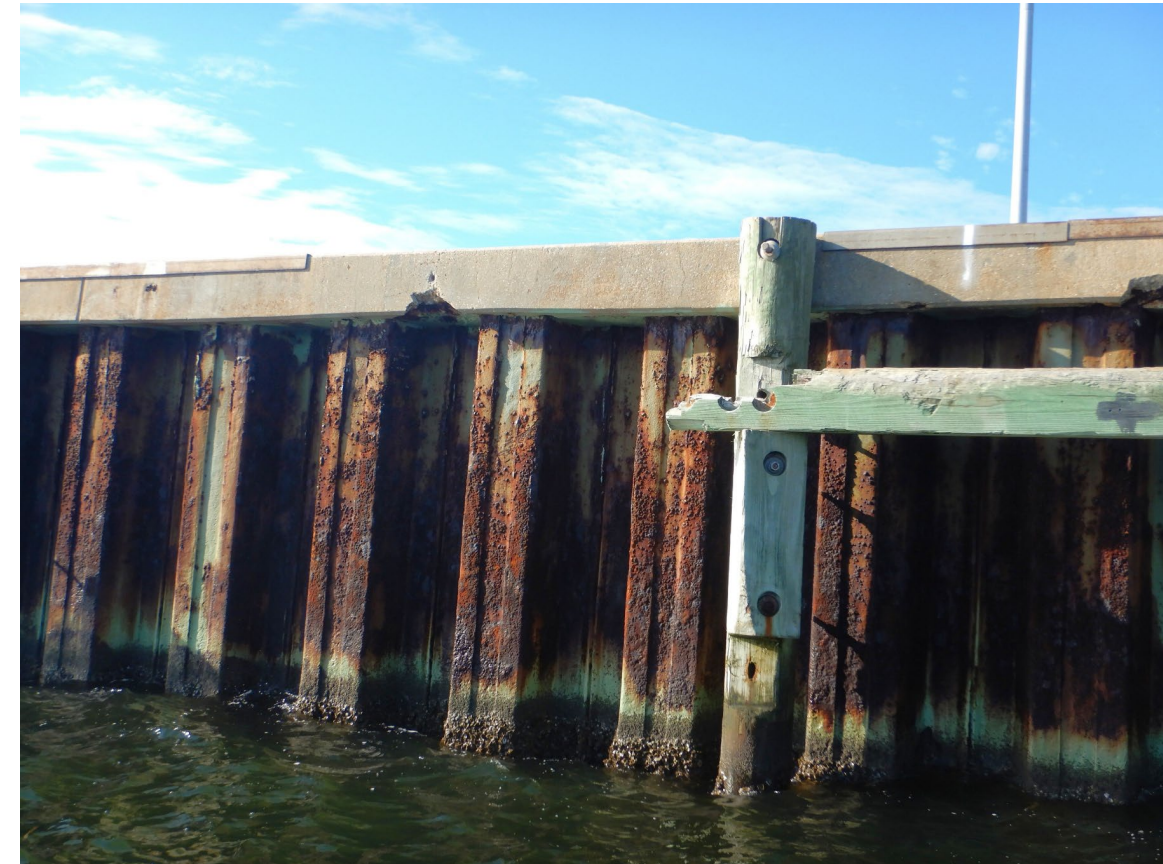
Splash Zone Corrosion

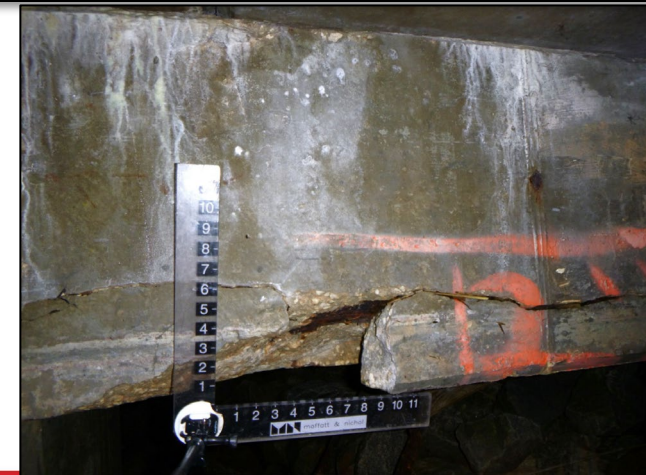
# Concrete Degradation – Corrosion Damage

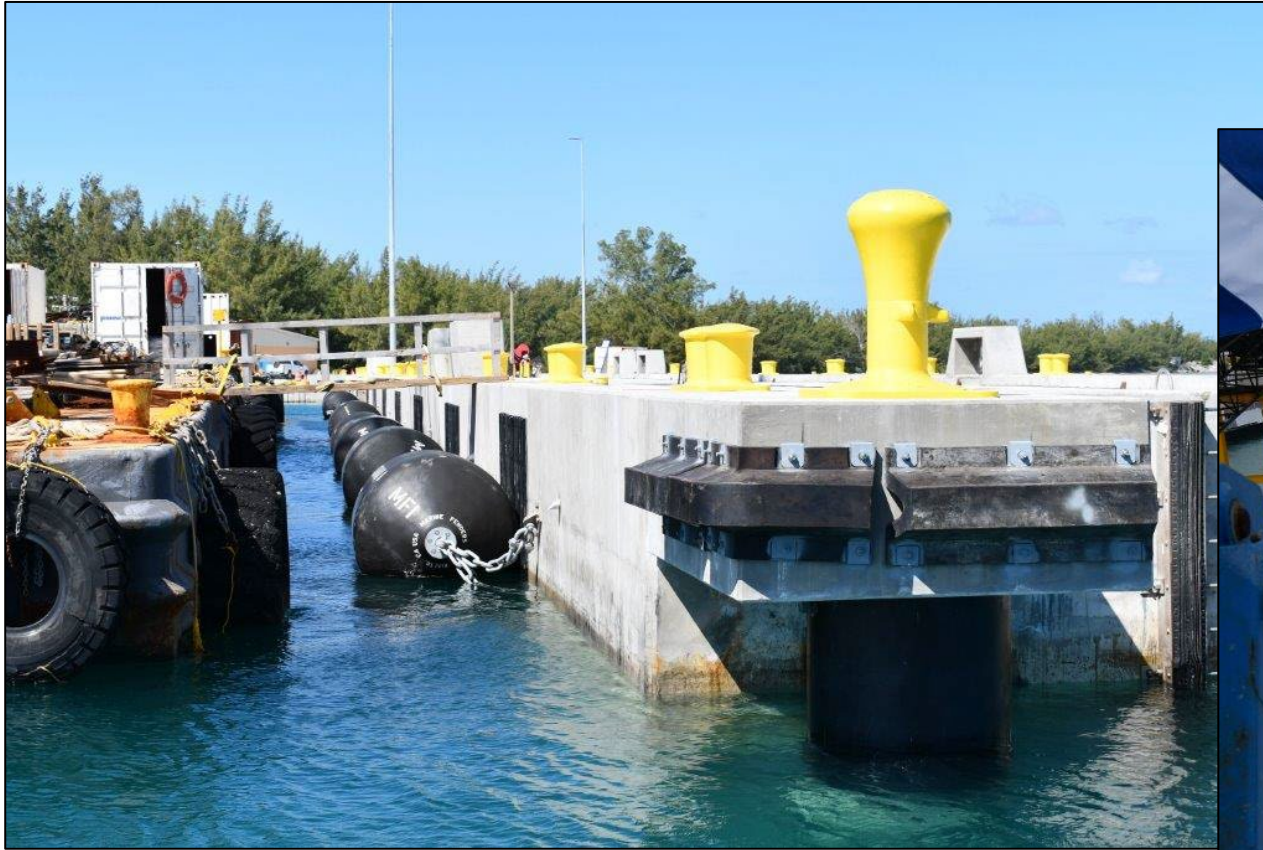
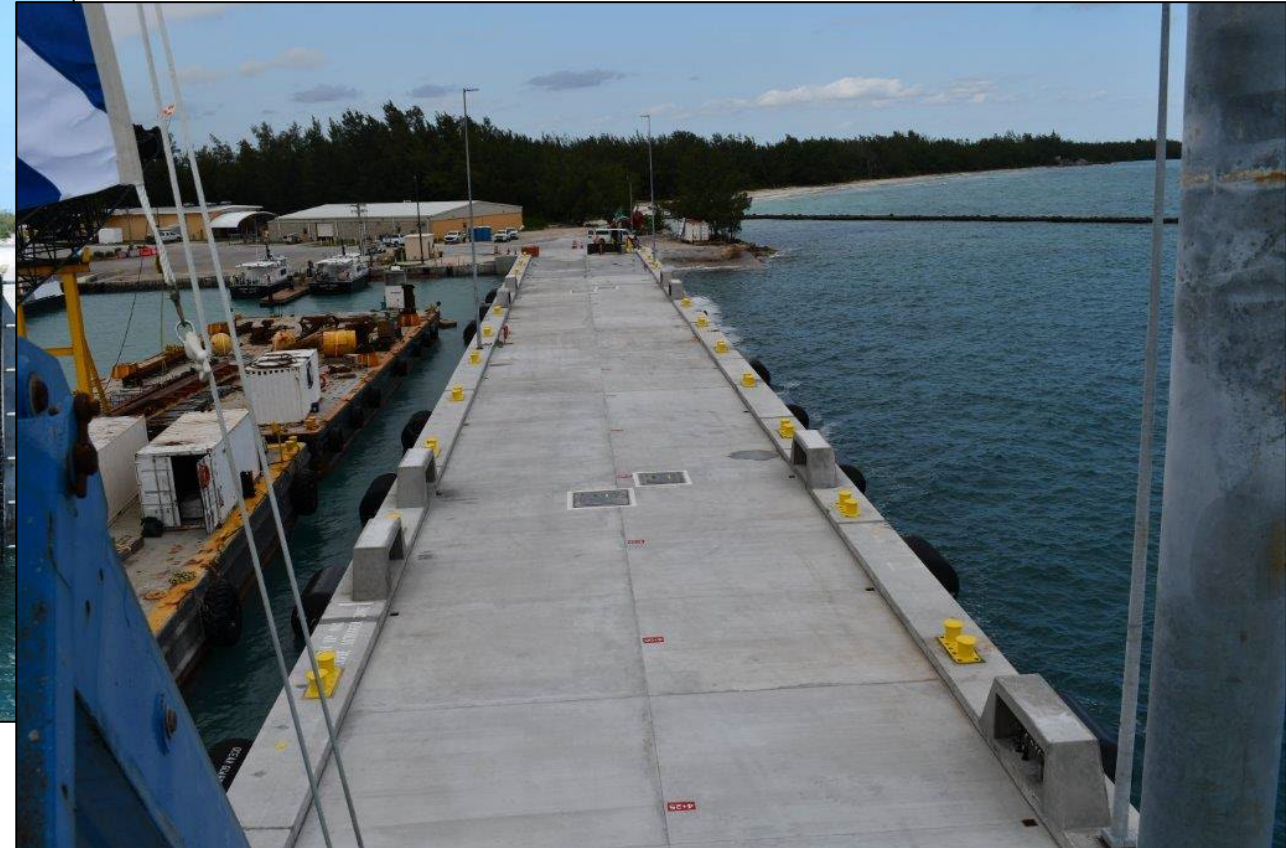
# AUTEC Andros Island - Pier Repair

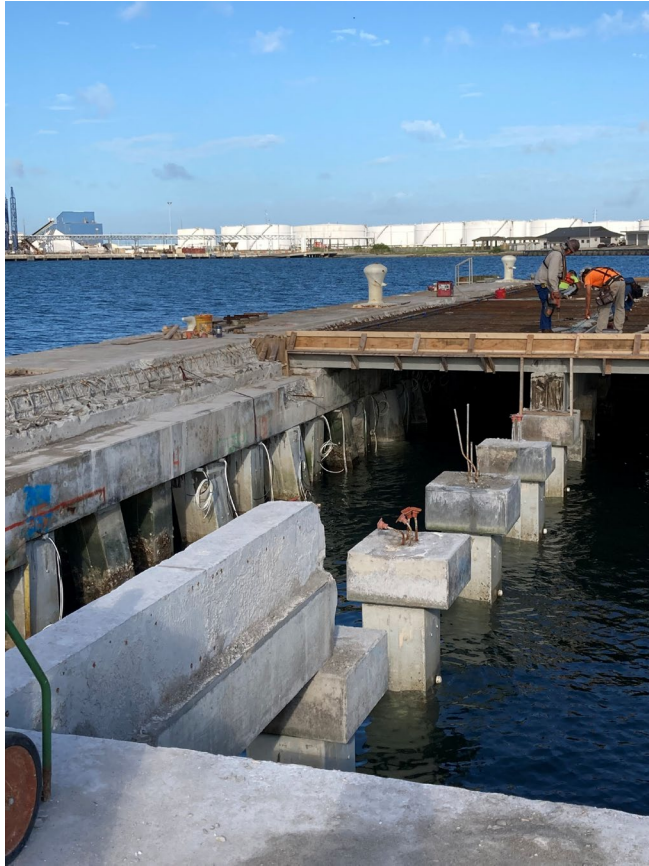
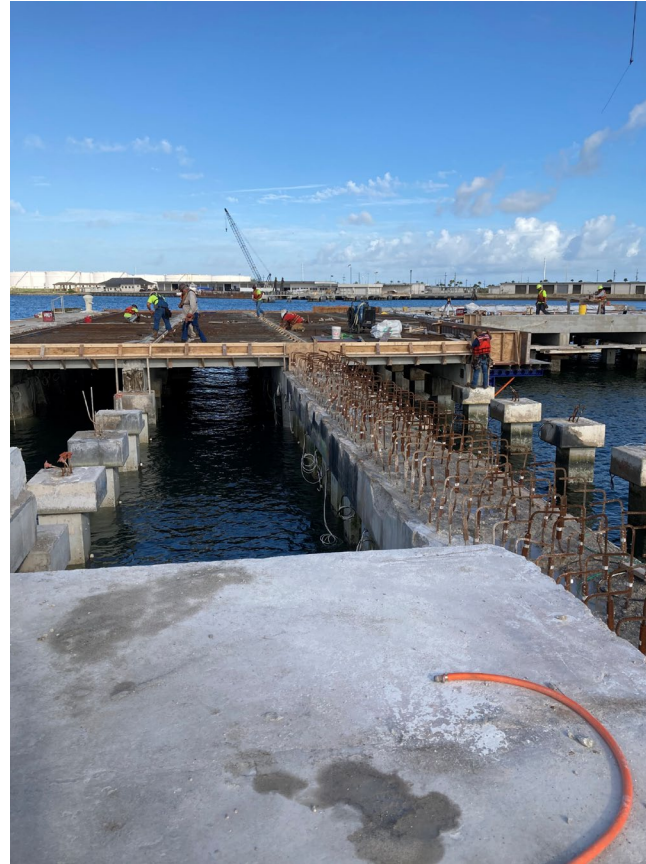
# Poseidon Wharf Repairs - Substructure

- Repair Substructure (pile cap concrete repairs and CP Pile Jackets)
- Replace Pier Deck for Mobile Truck Crane Operations
- Replace Utilities

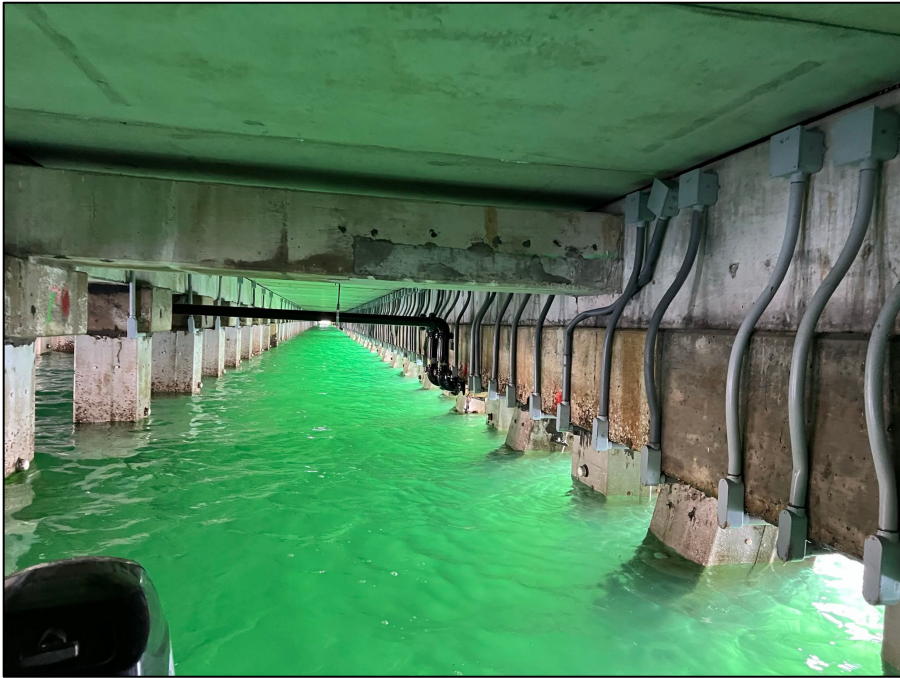
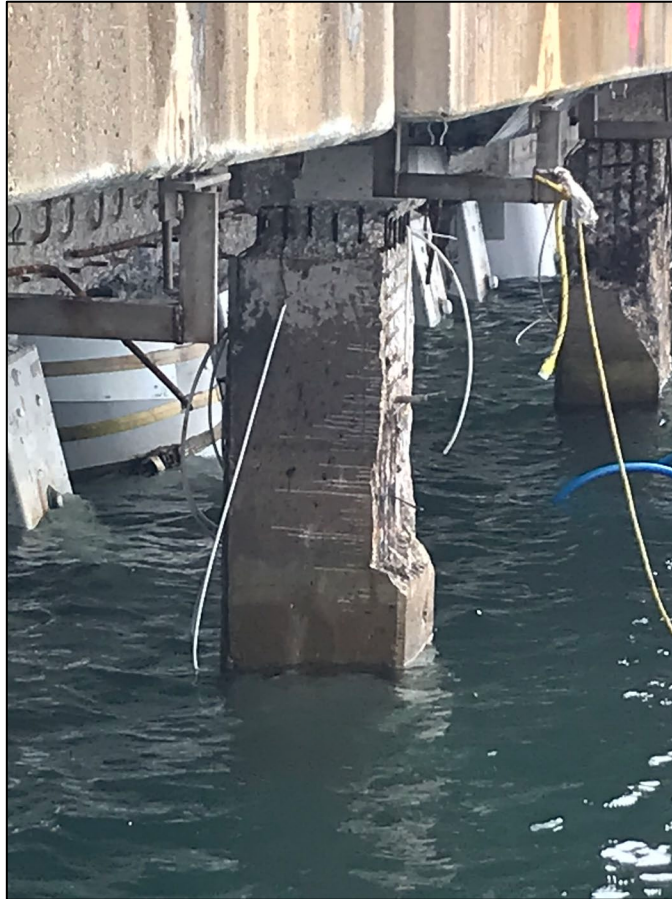
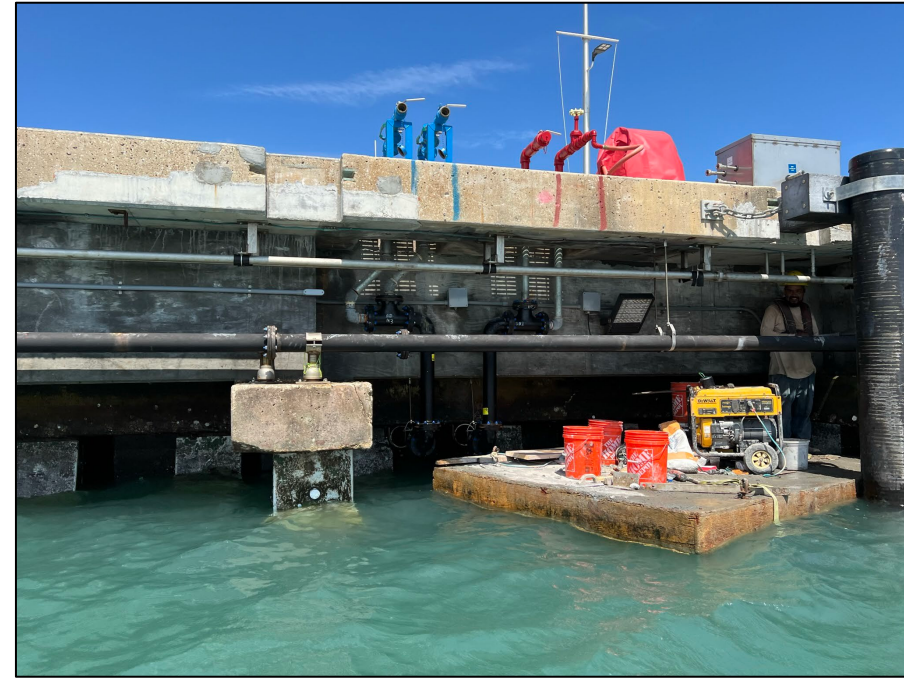
# Poseidon Wharf Repairs – Restoration

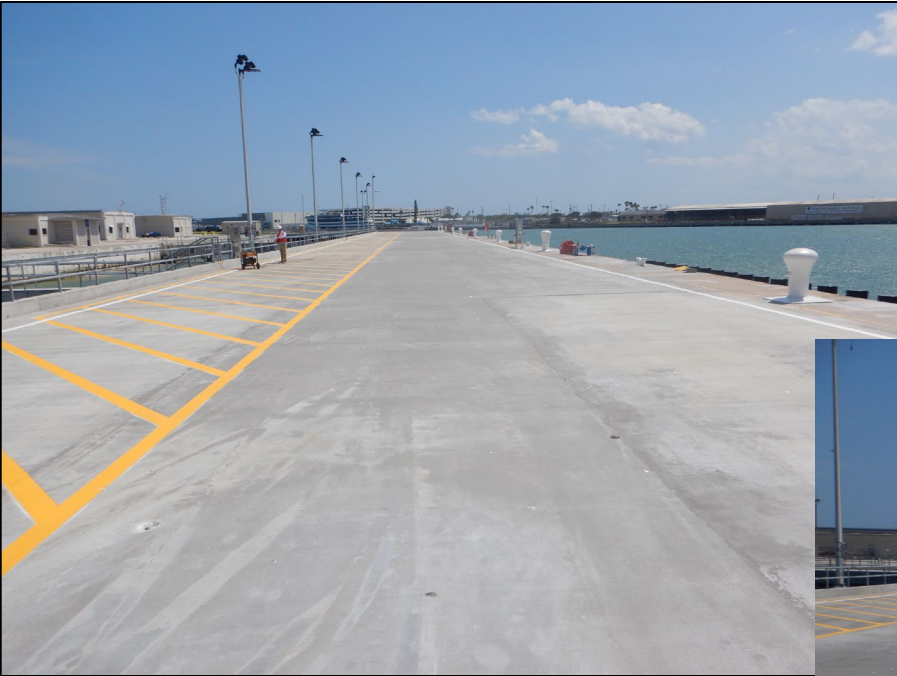
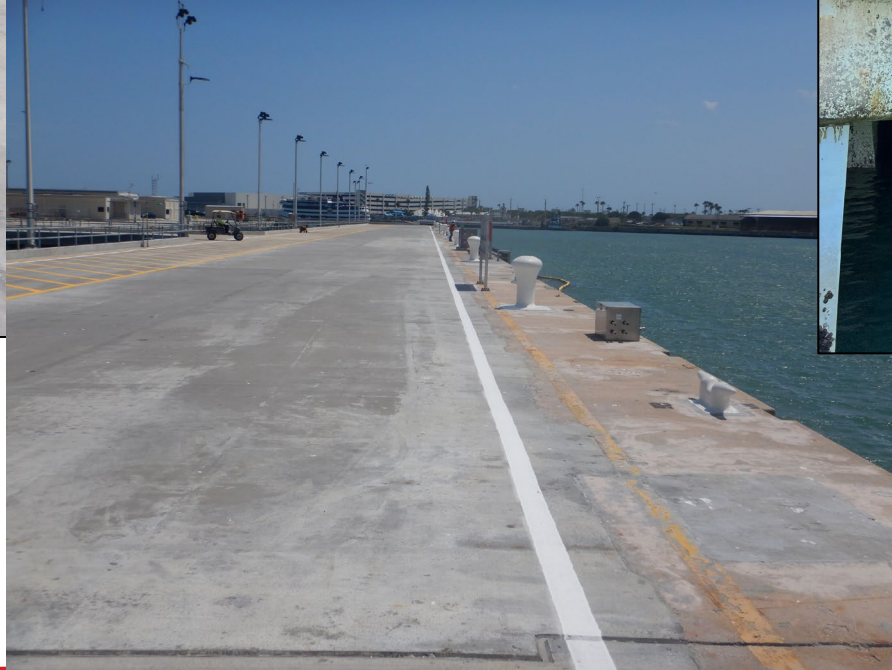
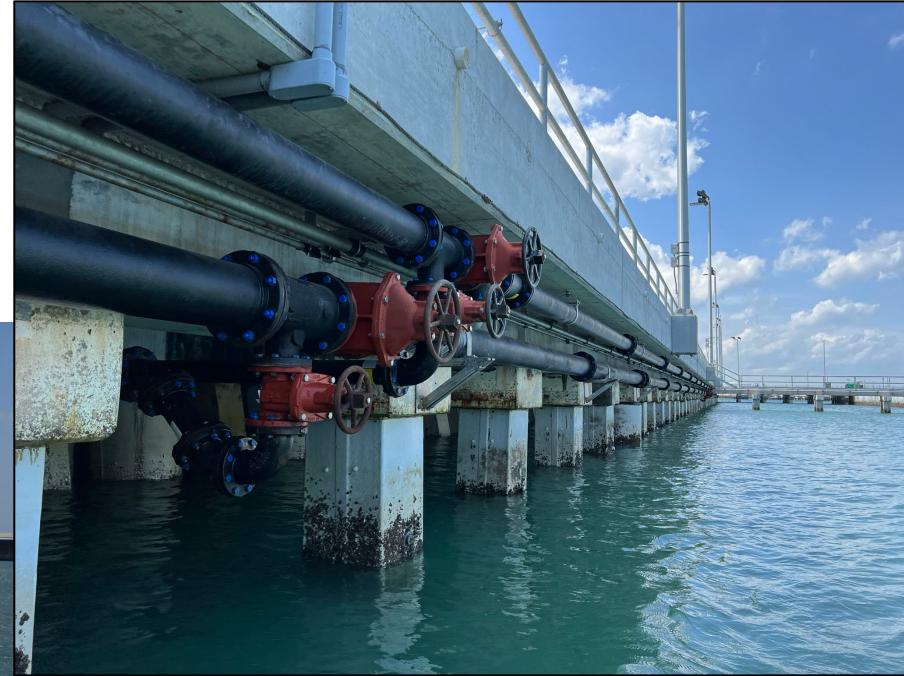
# Poseidon Wharf Repairs – Restoration

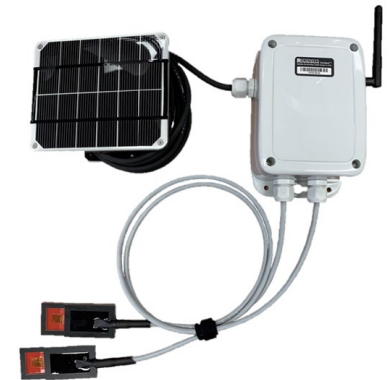
- Verify Analysis Assumptions and Loads on Structure
- Install strain gages and accelerometers attached to beams
  - Verify structural response to a known vehicle. Ex: fire truck
  - Update assumptions for load path through superstructure
- Weigh In Motion (WIM Array)
  - Verify vehicle weights that use wharf
  - Piezoelectric quartz sensors installed on a smooth stable paved surface
  - Develop site specific live load factors for the Wharf
